Development of a Study on the Establishment of the Klokot (Bihać) Spring Cross-Border Sanitary Protection Zones

FINAL REPORT

Zürich, 09.09.2020

HOLINGER AG

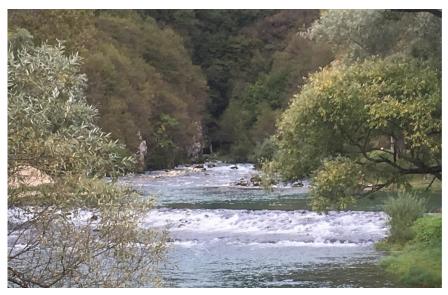
Figure 3.2: Klokot water source area

The water source of Klokot erupts from a karst cave at the foot of the Željavski plateau, i.e. the Baljevac field, forming a watercourse of the same name which flows into the river Una. In addition to the main water source in the immediate vicinity there is another water source Klokot 2, which is used for the needs of the pond.

Water intake at the spring is made by means of a concrete water intake facility located next to the water source. The water intake facility was built in 1968, and reconstructed in 1982 and 1998/99, together with the pumping station facility.

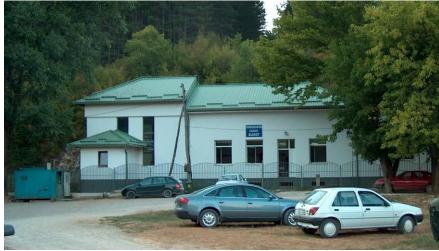
From the pumping station, the water is directed in two directions (reservoirs). In the first direction, the water is directed to the Komarac reservoir with two pumps with a capacity of 150 I/s, and from there it is further delivered to the city network. With the other two pumps with a capacity of 40 I/s (working and reserve pump), the water is directed towards the Klokotska glavica reservoir, i.e. towards the settlements in the north-western part of the city of Bihać. The two pumps, which were used to transport water to the Željava military complex, are no longer operational.

Figure 3.5: Pump station Klokot

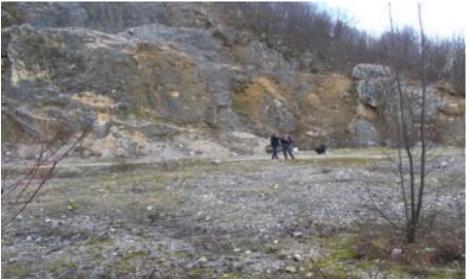
Figure 8.1: Quarry Baljevac (1)

Željava/Baljevac (1) – quarry is located near the military airport Željava. It was used for the exploitation of solid limestone, which was used for the construction of the airport as well as for other needs of the former Yugoslav Army (JNA). An explosive was used to scatter the slopes of the rock massif.

Inside the exploitation area of the quarry, there are the remains of a concrete separation structure for crushing stone. The quarry was active for several years after the war but without a work permit, after which it was closed without remediation measures. The quarry covers an area of over 0,5 ha, the volume of excavated material is estimated at 70,000 m³.

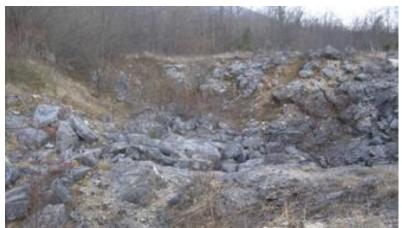
Figure 8.2: Quarry Baljevac (2)

Baljevac (2) – quarry, is also located near the military airport Željava and was also used for the needs of the former Yugoslav Army (JNA). It is a surface mining of limestone with prior agitation stone explosive with area 0,1 ha. After the exploitation was completed, the pit remained unrepaired. The quarry was not used after the war. The volume of excavated material is estimated at 4,800 m³.

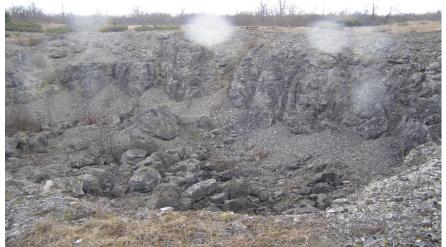
Figure 8.3: Quarry Baljevac (3)

Baljevac (3) – quarry is located in the immediate hinterland of the water source Klokot towards the military airport Željava. The quarry is believed to have been used by the former Yugoslav Army (JNA), as indicated by a surface limestone mine. The mined material was not all removed at that time and the quarry was later used illegally, leaving the pit unrepaired.

The distance of the quarry from the water source Klokot is about 1.6 km to the west, and therefore poses a danger to the source itself, in addition to the abandoned quarry (pit) leads a very well-built access road that can be abused for uncontrolled waste disposal or illegal activities. in the pit of a former quarry. The excavation area in the quarry is about 0.6 ha, and volume of excavated material is estimated at 35,000 m³.

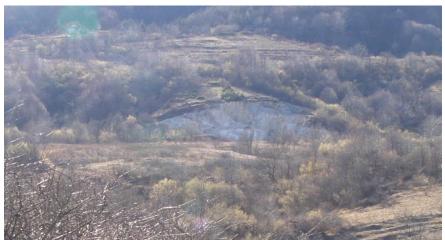
Figure 8.4: Quarry / material lender of dolomite stone near Zavalje near Bihać

Zavalje - Vučjak - The quarry / material lender is located near Zavalje in the direction of the closed landfill Vučjak. Dolomite stone and sand were mined at this site. The area occupied by the quarry is about 1.6 ha. The characteristic of this quarry is that it is made of cracked dolomite material with a lot of natural sand of a smaller fraction, so no explosives were used for exploitation, but construction machines. The volume of excavated material is estimated at 80,000 m³.

The quarry was closed without previous repairs, and access was prevented with the construction of a stone embankment on the access road. The access road is overgrown with low forest vegetation.

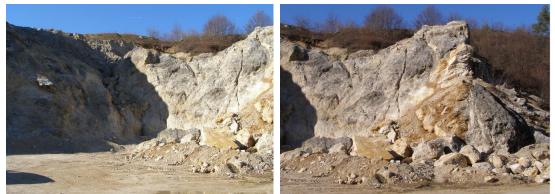
Figure 8.5: Dolomite stone quarry Međudražje

Quarry Međudražje is located near the settlement Međudražje and is the only one active in the catchment area of the water source Klokot on the BiH side. Dolomite stone and sand are exploited from the quarry. Most of the exploited amount is provided by blasting the slopes of the hill.

The area of the quarry is about 4.6 ha, volume of excavated material is estimated at 650,000 m³. Previously exploited areas that are no longer used have not been rehabilitated. Residents of the settlement Međudražje regularly complain to the competent services of the City of Bihać about the blasting at this quarry, during which there are significant shaking of residential buildings in the settlement Međudražje.

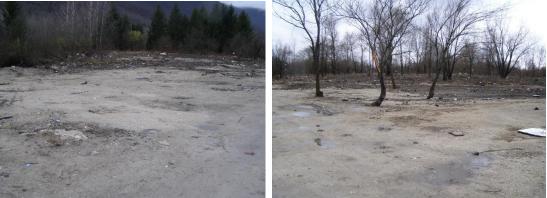
Figure 8.6: Old landfill Vučjak

Vučjak landfill is an old landfill in the city of Bihać. It is located about 5 km southwest of the city. Solid waste disposal was carried out until 1997, when the landfill was partially rehabilitated and closed. The body of the landfill is located in several sinkholes near the settlement Vučjak. By tracing the underground watercourses on October 9, 1984, a direct connection of this location with the water source Klokot was determined. Project documentation was prepared for the remediation of the landfill (The main project for the rehabilitation of the Vučjak landfill - IPZ Zagreb, 1985). The landfill was partially rehabilitated in the period from 1999 to 2001. According to the information obtained by several persons employed in public institutions of the City of Bihać, certain study and project documentation was used for the remediation of the landfill, but the landfill was rehabilitated by installing degassing pipes in the landfill body, and the landfill itself was covered with clay. in height from 1.0 - 2.0 m. The cover layer of clay is compacted

and is presumed to have been constructed to prevent the penetration of precipitation and surface water into the body of the landfill. After that partial rehabilitation, a forest about 15 years old grew on the body of the landfill. The amount of leachate seeping into the ground through the body of the landfill is not known, nor have subsequent hydro-geological and hydrological surveys been carried out at this location.

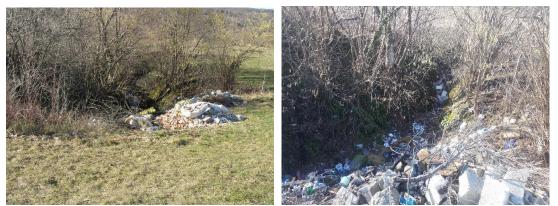
Figure 8.7: Wild landfill Bezdan in the settlement Međudražje

Illegal landfill Bezdan (Međudražje) is a landfill with uncontrolled / illegal disposal of municipal waste located in the settlement Međudražje. The landfill is about 200 m away from the regional road and houses in the village. The landfill is a natural bay of approximately 20.0 x 2.5 m with a variable depth of 1.0 to 2.5 m. Mostly about 10 households dispose of municipal waste, glass, PVC, packaging and construction waste at this landfill. The intensity of waste disposal is low, because it is used by a small number of residents of the mentioned settlement.

During a field visit, the Bezdan landfill in Međudražje was identified as the only currently active illegal landfill in the catchment area of the water source Klokot, in Bosnia and Herzegovina.

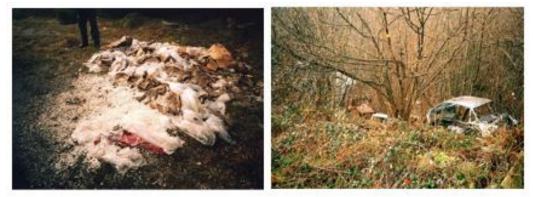
Figure 8.8: Wild solid waste landfill at the Baljevac site (archive recording from 2003)

Bulky metal objects were previously removed from the landfill, but the location is densely overgrown with low and high vegetation and it is impossible to identify it without prior cutting of vegetation.

Waste is no longer disposed of at the said landfill; however, the landfill was registered as a potential contaminant because at that time the origin and composition of the deposited waste could not be determined with certainty.

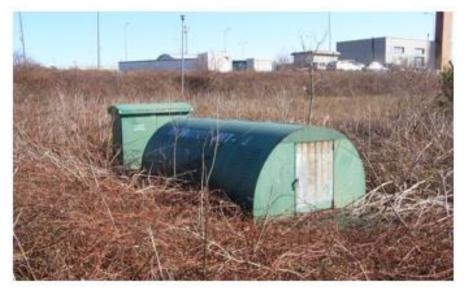
Figure 8.10: Biological wastewater treatment plant at BC Izačić (BiH) / BC L. P. Selo (Cro)

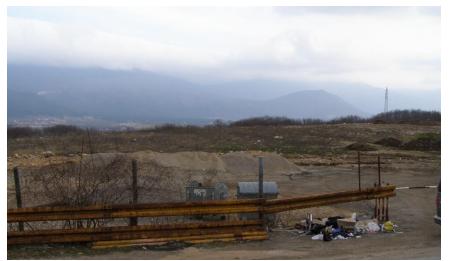
Figure 8.13: Municipal waste landfill Vrpile (Korenica) in the sanation phase

Landfill Vrpile / Kalebovac - Korenica - is certainly the most important landfill for municipal waste in the Klokot catchment area in the territory of the Republic of Croatia. It is located at a distance of 2.5 km southwest of the city, in the locality Ljeskova poljana, Kalebovac. The land-fill was closed at the end of 2019, it is fenced, and there is a gate with a lock at the entrance. Currently, municipal waste in a weekly production of about 50-60 m3 is collected in a container and taken to a landfill in Karlovac.

During the construction of the landfill, no protective foils were placed on the substrate, and waste disposal was performed with the stabilization of the layers with inert material. Also, the system of degassing, drainage and purification of leachate has not been built. The landfill area covers an area of 1.6 ha.

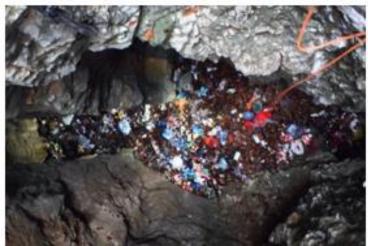
Figure 8.17: Illegal landfill pit near the mouth of Plitvice

Significantly polluted pit in the settlement of Poljanak. At the bottom of the building there is a lot of waste (dozens of cubic meters) which directly endangers the river Plitvice near the mouth of the river Korana. Pollution is located along with the very fundamental phenomenon of the Great Waterfall in Plitvice. The dimensions of the entrance to the pit are 10 x 15 m with a depth of 25 m. Pollution was recorded in 2019.

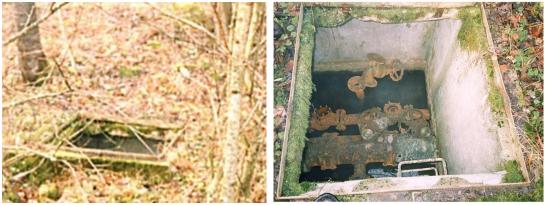
Figure 8.22: Inspection shafts on the route of the pipeline for the transport of kerosene to the airport Željava (Archive photo from 2003)

Kerosene for airplanes was delivered by pipeline from the main warehouse in the settlement of Pokoj near Bihać to the kerosene outlet near the so-called "Triangle" at the airport. The main kerosene tank was located outside the mountain range. The route of the transport pipeline is not known, during the inspection of the terrain it was not possible to identify the route or inspection shafts due to the overgrown vegetation. According to previously available information, there is no kerosene in the pipelines, because it was extracted during the 1992-95 war years.

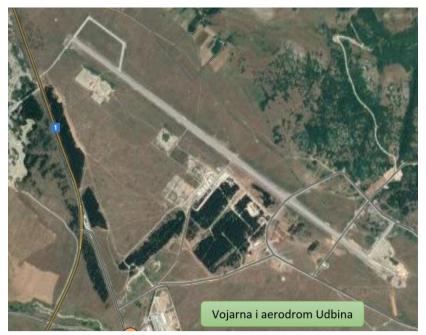
Figure 8.23: Spatial coverage of the military quarter and Udbina airport

The airport and military quarter in Udbina is a military facility that is active. The military quarter has an internal sewerage network with a septic tank that is periodically emptied. The facility has an approval in terms of meeting water requirements. The spatial coverage of the airport and military quarter is about 75 ha. The space is completely fenced, there are no fuel tanks or gas stations inside the space. Fuel for the regular needs of the military facility is delivered by tank.

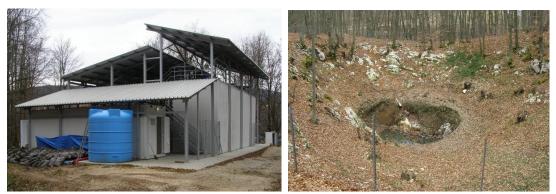
Figure 8.24: Temporary WWTP (MBR type) and discharge pit "Rastovača "

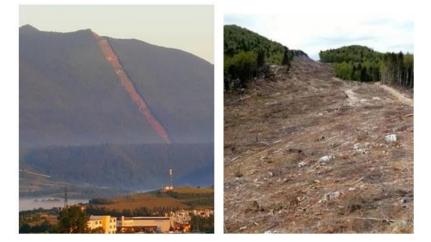
Figure 9.4 Deforestation on Plješivica mountain

According to available information, logging is planned on the intersection of the corridor about 8 kilometres long and 100 meters wide (80 ha), but the situation on the ground can determine that the area of felled forest is much larger, and is estimated at an area of about 150 ha.
